**Haworth
Residential
Inspections LLC**

Home Inspection Report

1234 Your Street
Lawton, OKLAHOMA 73507

2016 September 16, 2008

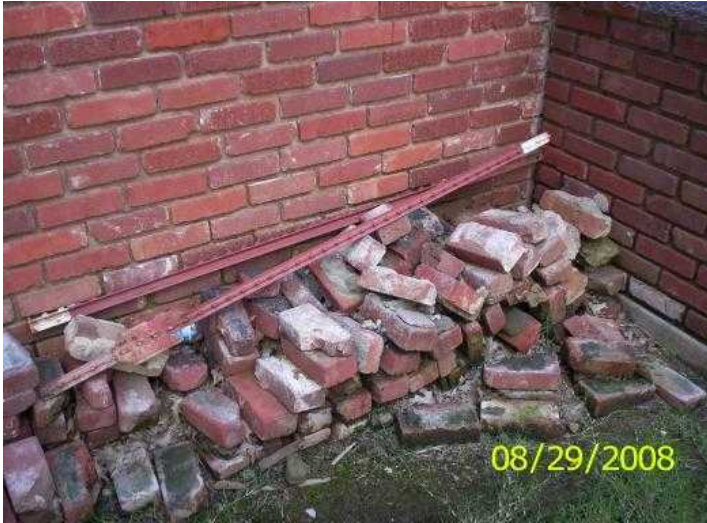
Bricks and mortar piled against wall , possible safety hazard and possible insect

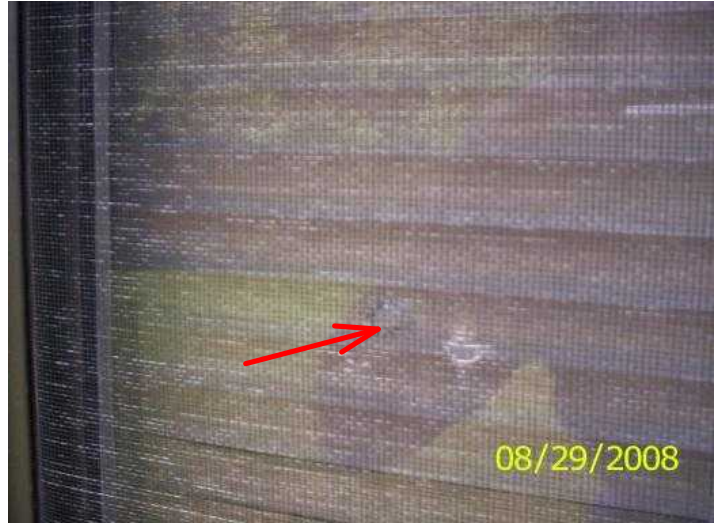
Cracked, broken or missing glass ,north bottom window by garage door .

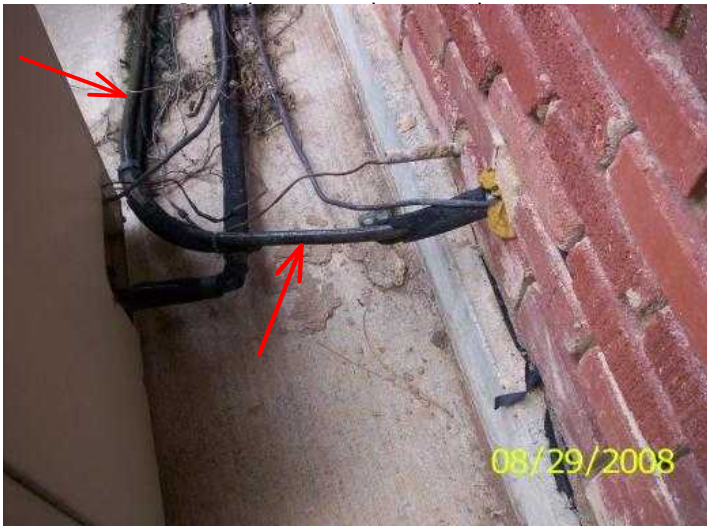
Torn insulation

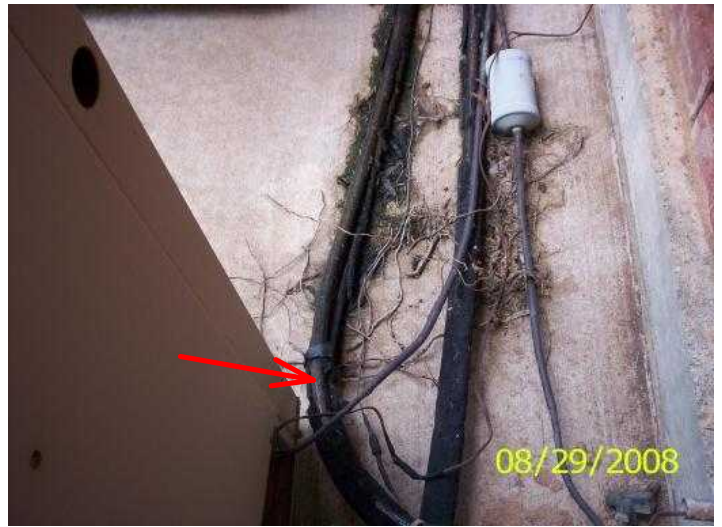
Torn insulation

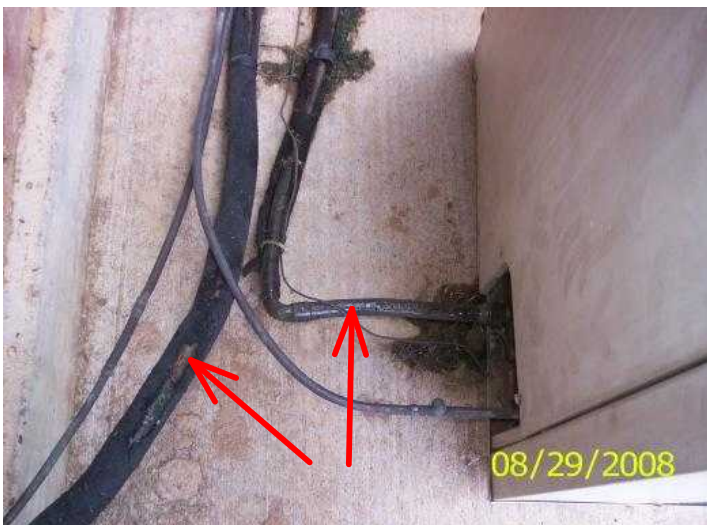
Torn insulation

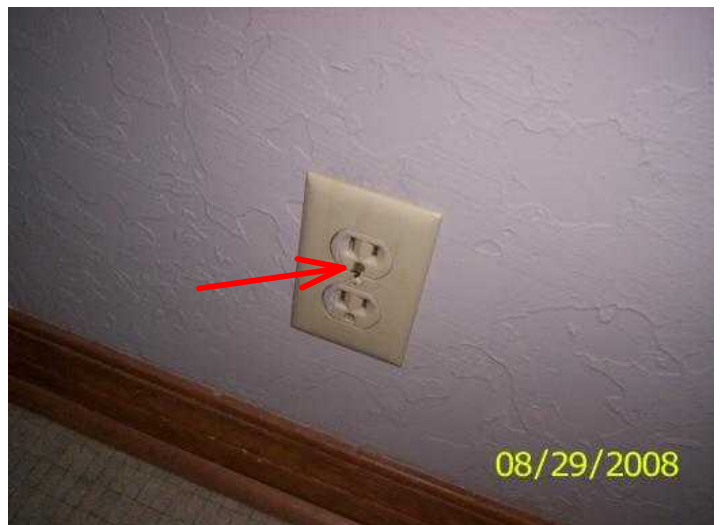
Non-GFCI circuit by sink. Plug by toilet has ground broken off in it.

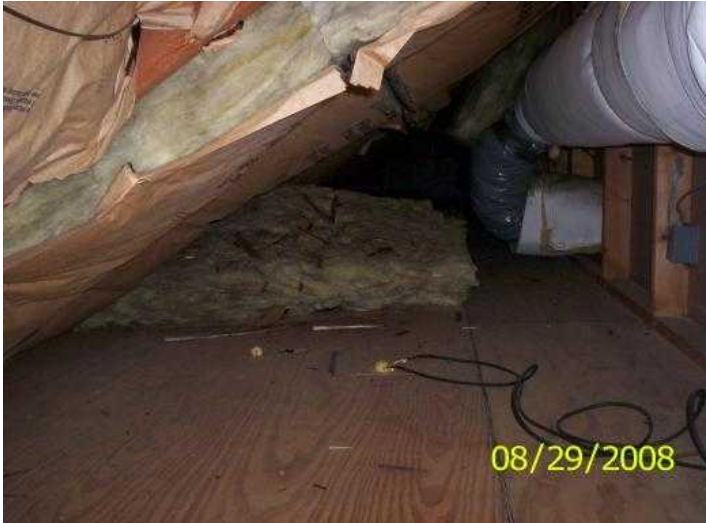
Insulation batts have fallen out of position-properly reinstall

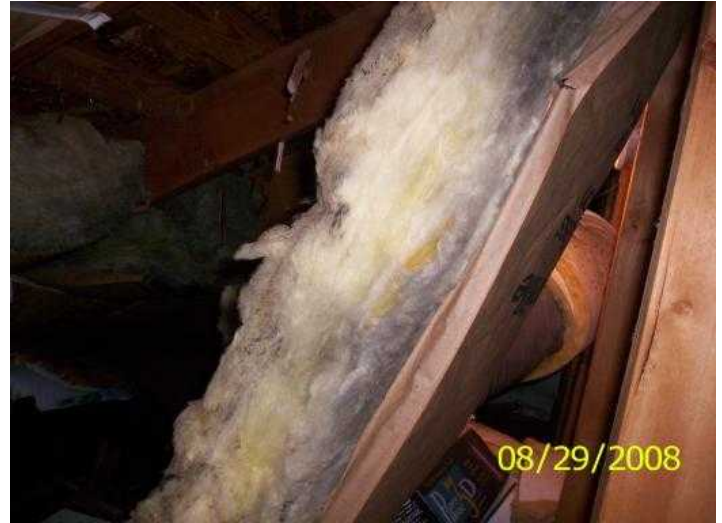
Insulation batts have fallen out of position-properly reinstall

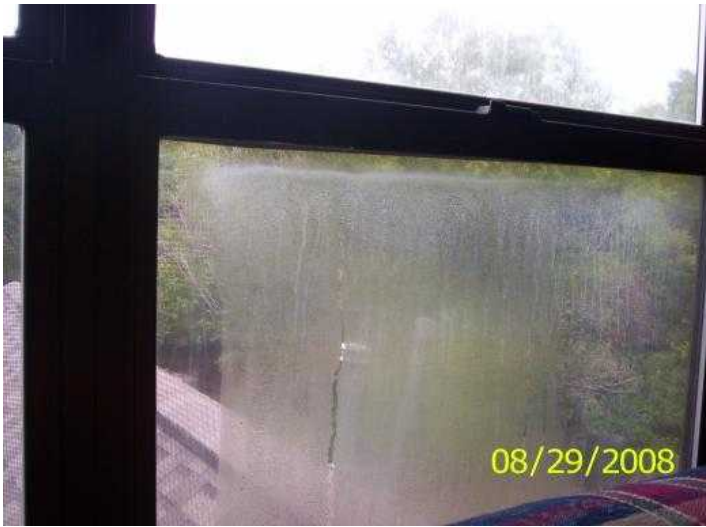
Moisture present inside the layers of glass, south window

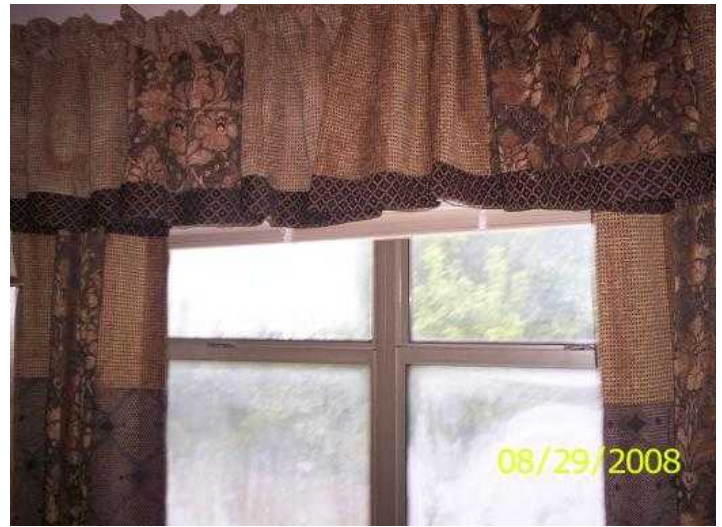
Both west windows will not open. Window has fogging between the layers of glass, all windows in the sitting area.

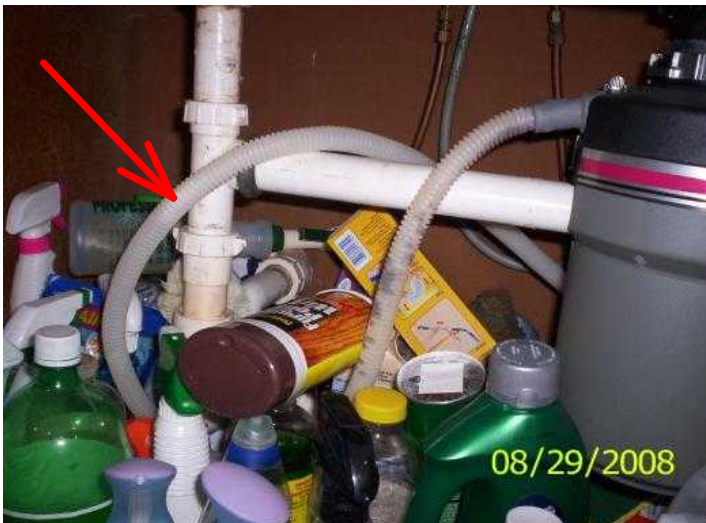
Air gap hose improperly connected
